# Construction of Hume Dam, 1919-1936

## Part 9: The 'U' Tube nears completion

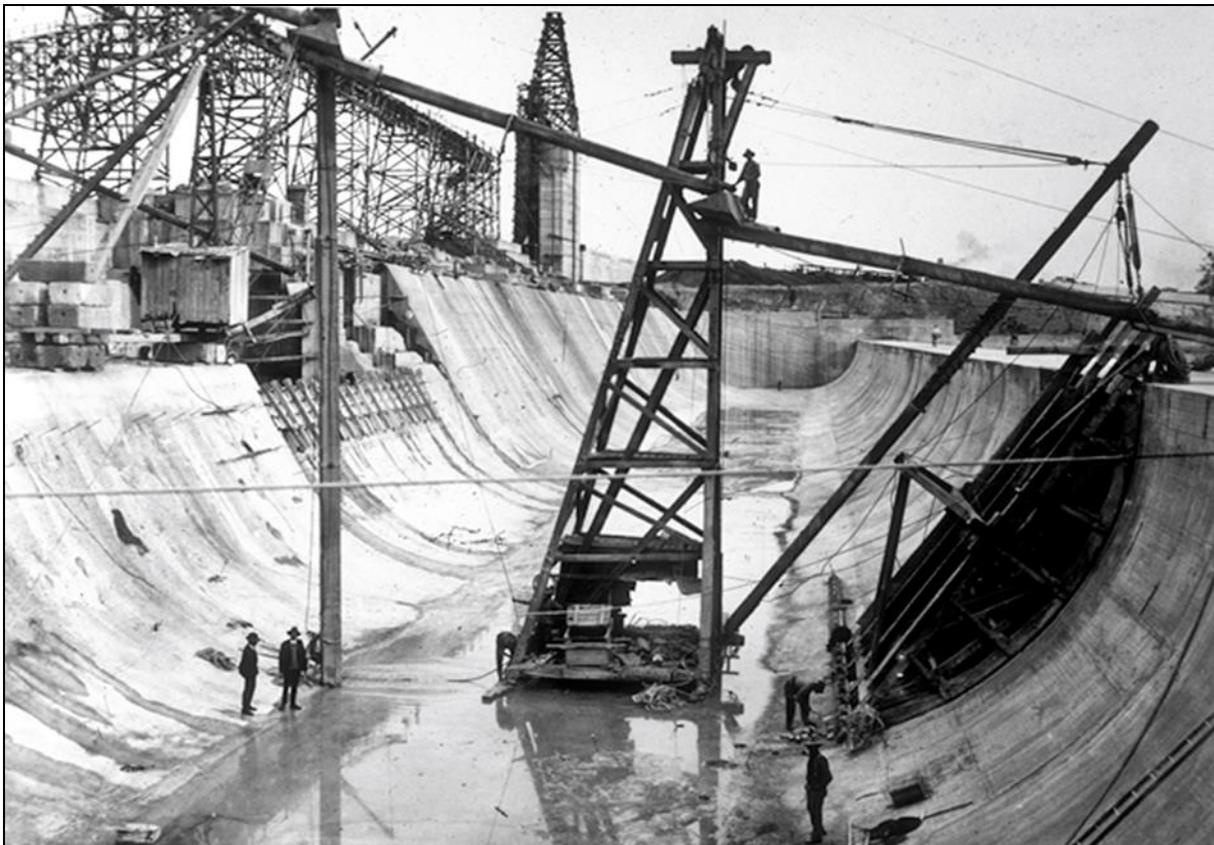
A dry dissipator trough and wall is not an everyday sight.

The dissipator wall is 220m long, 7.5m high, its crest is 4.18m wide while its base extends for 12m downstream. Unlike the stilling pool beside it, which has an upturned ramp at its downstream extremity, the base of the dissipator wall has a five-metre downturn to bedrock for its downstream foundations.

The photo shows a workman in a precarious position on a concrete chute, directing concrete into this downstream section. OH&S issues did not complicate working life in the 1930's. The curved formwork is not in use but shows how the wall was built. On the spillway, a small section of formwork is in place. Bronze bolts were inserted into the wet concrete. When set, this allowed the boxing to be bolted to the wall when it was lifted for the next pour. The spillway's main slope is 64 degrees.
